SANbox[®] 5200 and SANbox2[™] Firmware Release Notes Version 4.0.0.11

50207-16 Rev A

Version 4.0.0.11 is a new platform release for the QLogic SANbox 5200 switch product line. In addition, this release supports all SANbox2 switch products. If using the SANbox Manager[™] fabric management application, you must use SANbox Manager version 4.00.10, or later, in conjunction with this firmware.

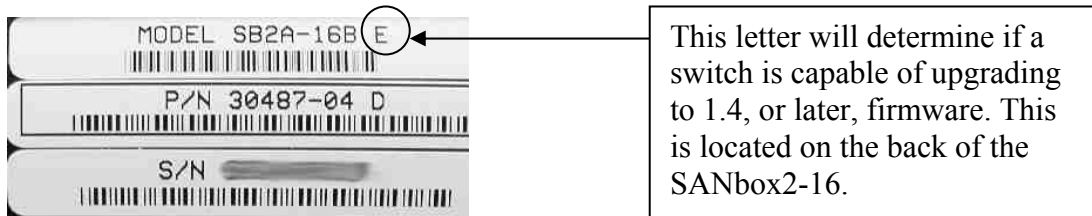
1. All SANbox2-16 switches with model numbers ending with the letters A through G (see below) cannot upgrade to the 1.4, or later, firmware release without contacting QLogic Technical Support first. Technical Support contact information can be found at the end of these release notes.
